Private Cloud Health Check Report

A total of 15 potential downtime and data loss risks were detected by AvailabilityGuard/Cloud health check assessment of your private cloud environment.

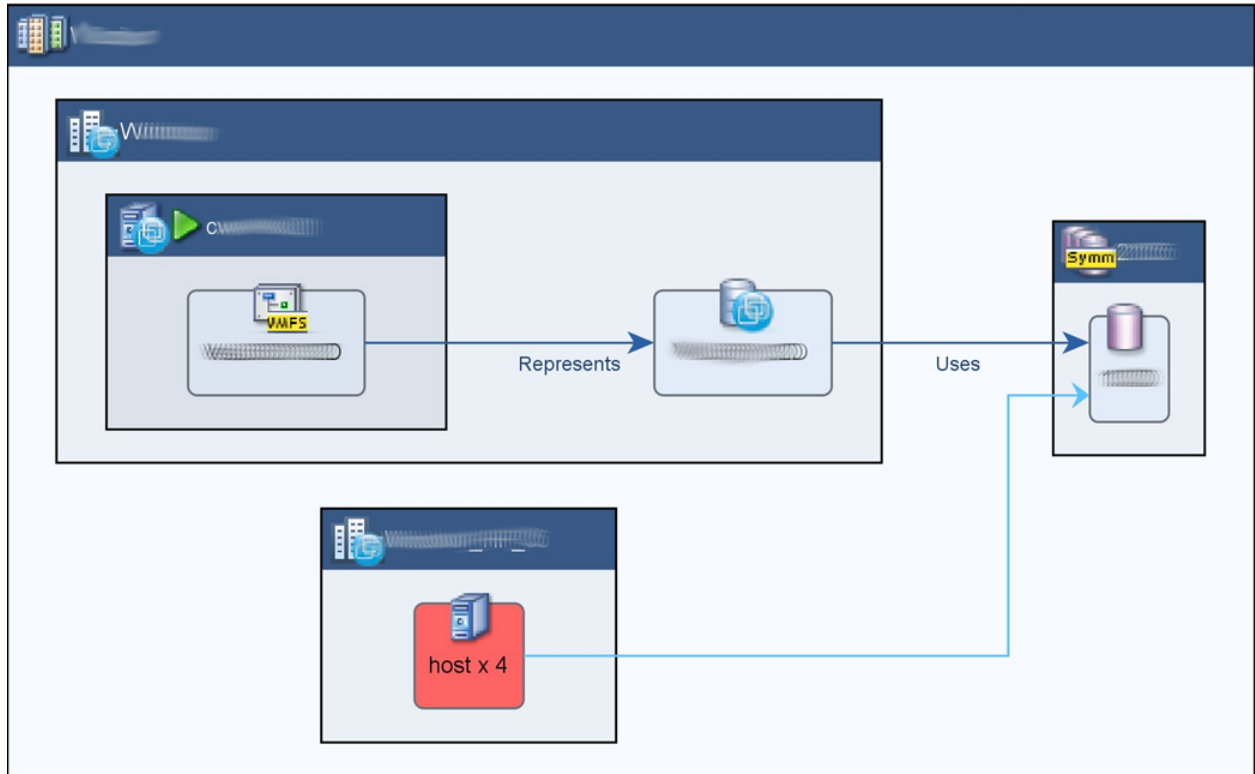
TICKET 31

VMware datastore **VD12** defined in datacenter **London** is accessed through the SAN by unauthorized hosts.

VMware datastore **VD12** defined in datacenter **London** at site **London** is using Symmetrix device which is accessed by ESX hosts that are not members of the same datacenter. This might lead to data corruption (see impact).

Symmetrix devices allocated for datastore use should be mapped only to ESX servers that are members of the same datacenter. This can be useful to allow migration of virtual machines using VMotion. However, it is highly dangerous to allow SAN access to the underlying Symmetrix devices by any other host, especially if one is not an ESX server. This might result in unexpected data corruption and data loss that will affect any Virtual Machine using the datastore - which might also lead to downtime.

Remove the SAN mapping of the Symmetrix device to the unauthorized hosts.

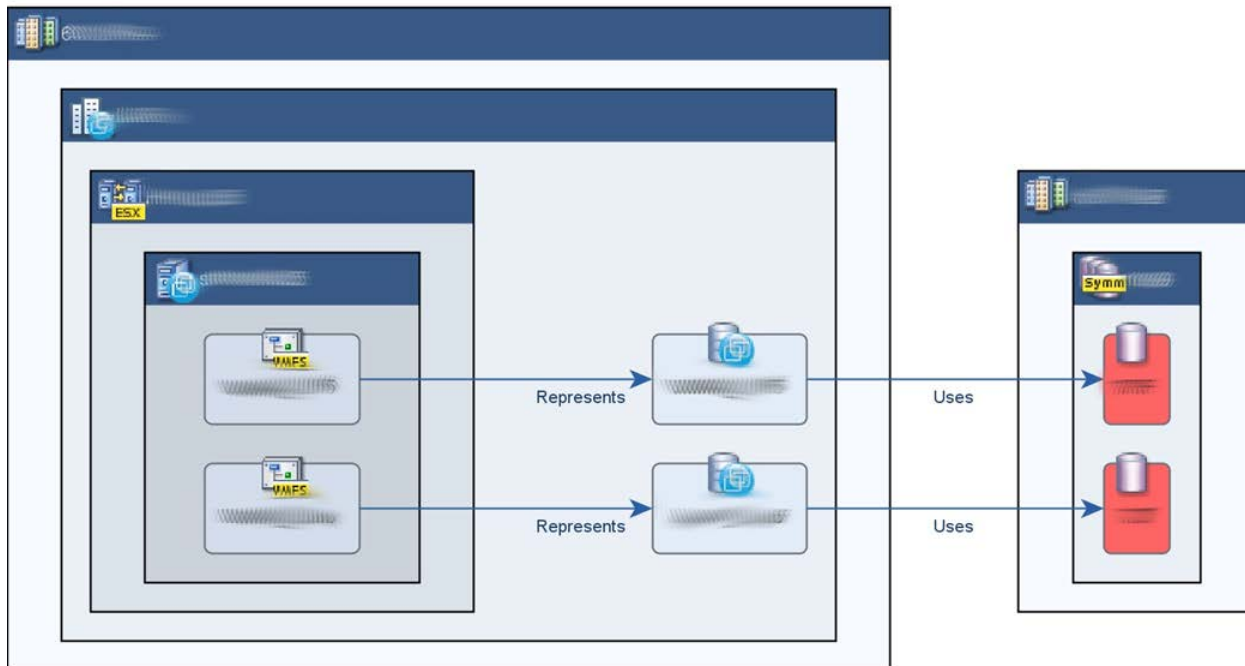
TICKET 46

ESX cluster node **VC-9b4** of ESX cluster **HP-BL-680** at site **Tokyo** is utilizing storage volumes located at site **Kofu**.

ESX cluster node **VC-9b4** of ESX cluster **HP-BL-680** at site **Tokyo** is utilizing storage volumes located at site **Kofu**. This might result in performance degradation and unexpected outage.

The host may experience sub-optimal performance. Also, additional load on the network is generated, which potentially can be avoided and may impact the performance of other replication sessions.

Finally, unless the configuration is intentional, then any planned or unplanned outage of site London might lead to unexpected errors or failure of ESX cluster node **VC-9b4** of ESX cluster **HP-BL-680**.

Unless configured this way by design, migrate the storage volumes used to the local site. Pay attention to using the right storage tier and performance characteristics for the new storage volumes.

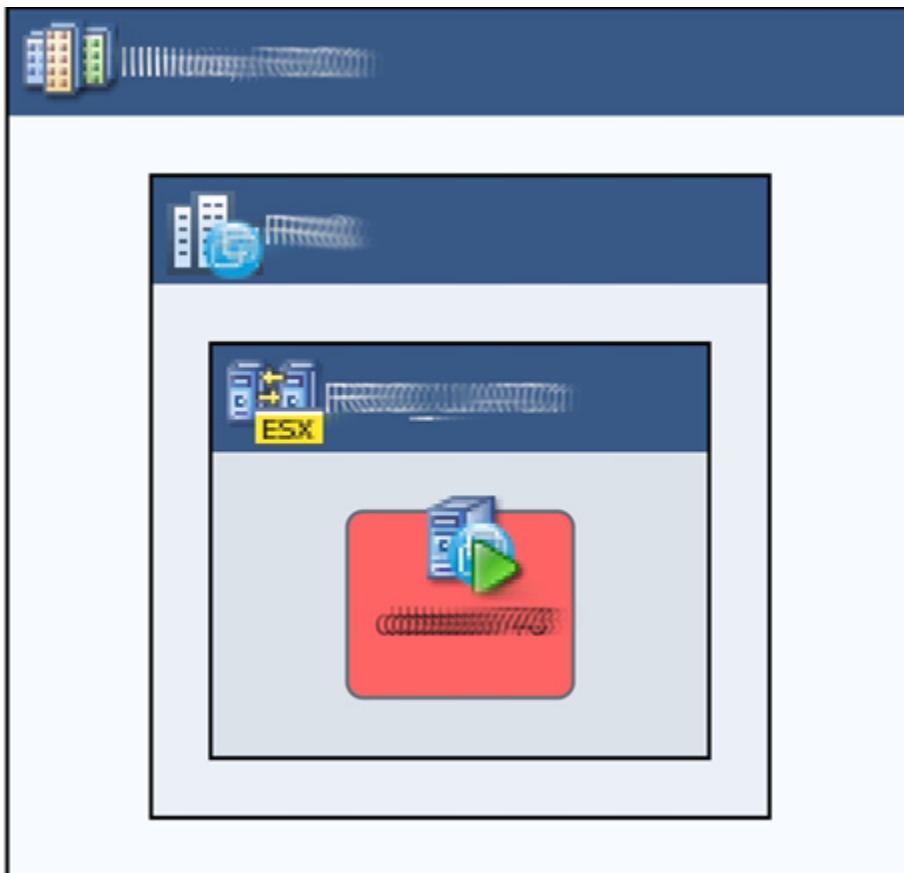
TICKET 185

The LVM.DisallowSnapshotLun option is disabled on ESX cluster node **PD-CL-54** of ESX cluster **ST-NT-04** at site **NEDC-12**.

By default this option is enabled, to prevent duplicate allocation of the same VMFS from two (or more) different disks. A gap has been detected where this option is disabled on ESX cluster node **PD-CL-54** of ESX cluster **ST-NT-04** at site **NEDC-12**. This might lead to unexpected behavior in the ESX configuration (see impact).

Keeping **LVM.DisallowSnapshotLun** disabled (set to "0") on an ESX host might result in conflicting storage access and data loss when Point-in-Time copies are created at the storage layer. Since both source and target (copy) disks LUNs have the same disk ID, ESX will map each pair to the same VMFS. An attempt to write to the target will result in data corruption of the source.

Make sure that possible maintenance work has been completed and change the value of the option **LVM.DisallowSnapshotLUN** back to "1".

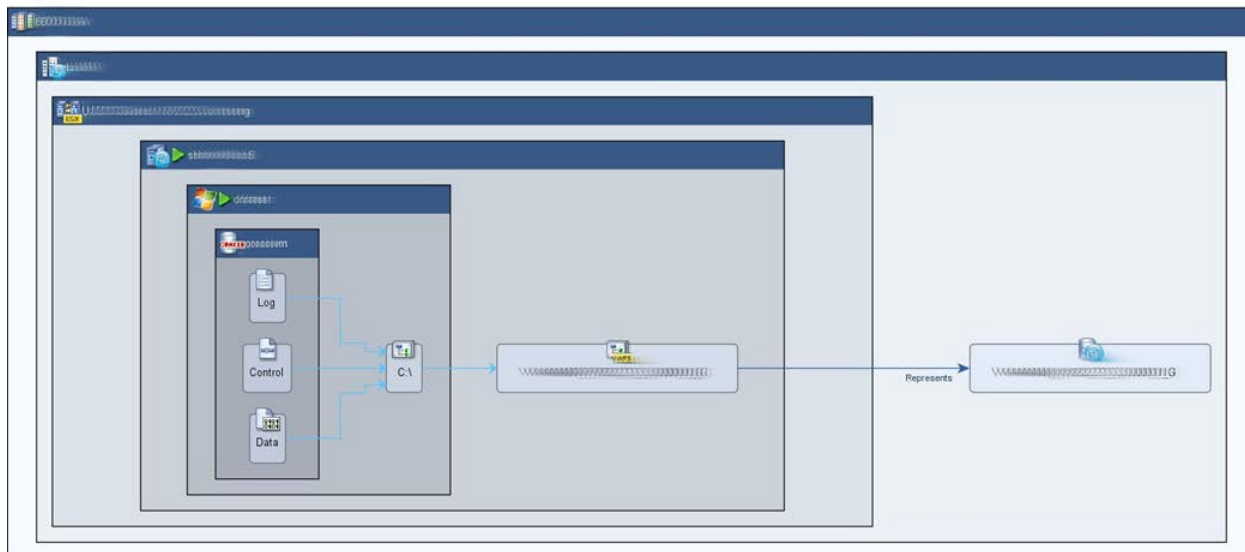
TICKET 42

Local file system C:\ on Windows VM **rgfab** at site **Tokyo** contains a mixture of database files.

Having different database file sets stored on the same storage volumes may result in incomplete copy of one or more of the databases, if future use of Point-in-Time copies is planned for these databases. In addition, performance issues may arise. Furthermore, it is recommended to store each database on a separated set of storage volumes.

If different file types are stored on the same storage volumes, they would compete over the same I/O resources, possibly resulting in suboptimal database performance. Moreover, since data files and transaction log files are the two most I/O intensive components of the database, it is a best practice to store different file types on separated storage volumes and spindles. This minimizes contention for the logs as new writes come in from the database and any old transaction log information is streamed out during incremental transaction log backups. It also isolates the sequential write and random read activity for these members from other volumes with differing access characteristics.

Consider separating your databases into different groups of storage volumes, thus eliminating data corruption risk and optimizing performance.

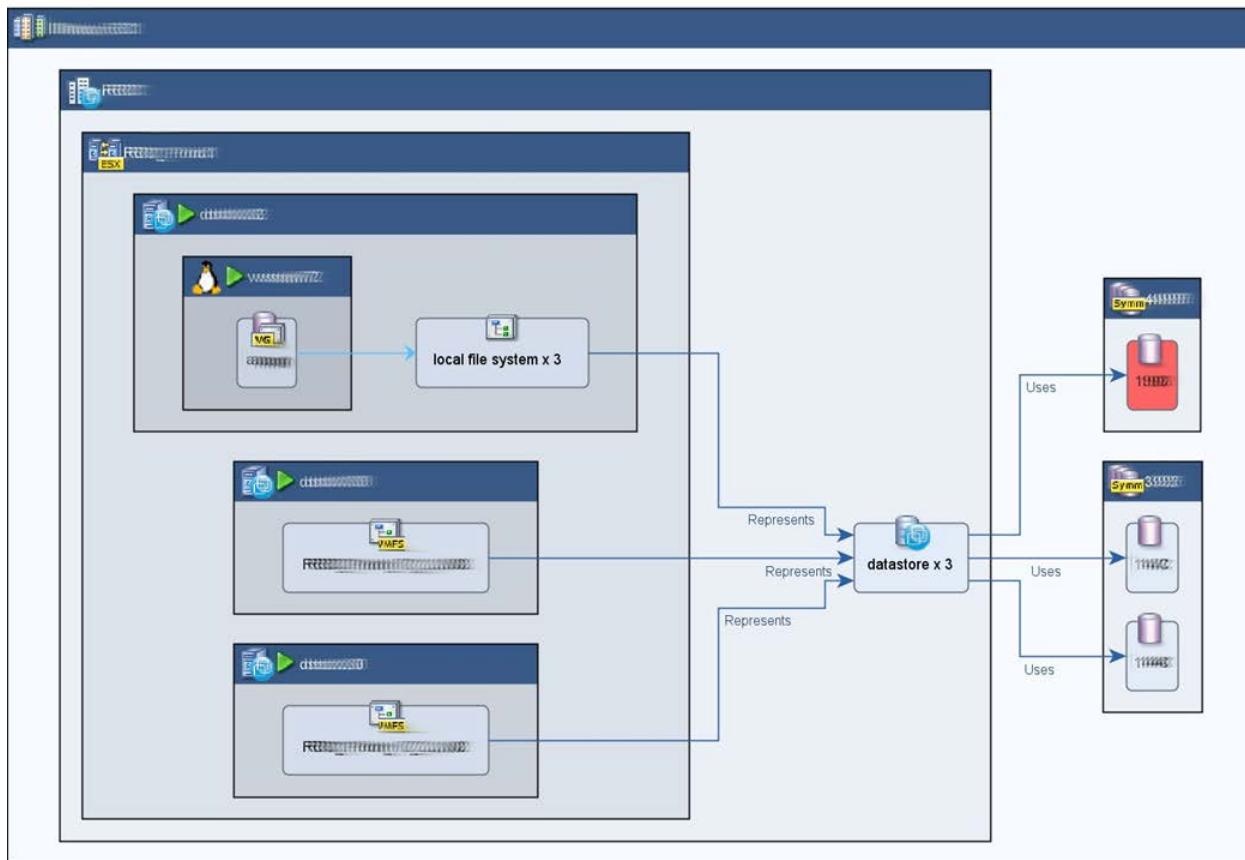
TICKET 173

Storage array inconsistency was detected on Symmetrix devices storing VG **ws-prd-vg** on Linux VM **prd-ws-ne-56** at site **NEDC-12**.

VG **ws-prd-vg** on Linux VM **prd-ws-ne-56** at site **NEDC-12** is stored on Symmetrix devices of different storage arrays.

This might result in degraded performance and data corruption or loss (see impact).

Since the data is stored on several arrays, it will suffer downtime even when only one of the arrays is down.

Review the mappings to the Symmetrix devices and consider remapping them on the same storage array.

Otherwise, consider using consistency group (Composite group with enabled consistency mode) on those storage volumes.

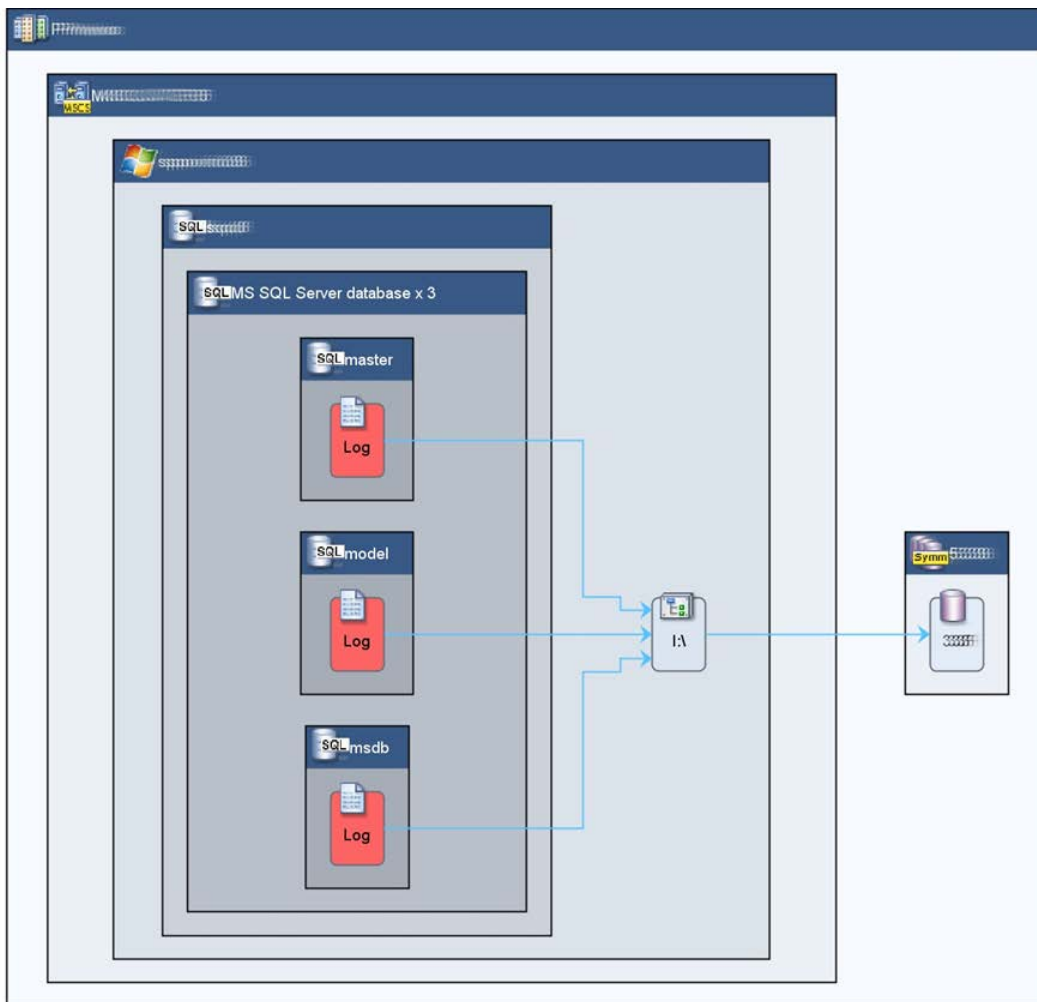
TICKET 118

To achieve optimal performance, it is a best practice to store database log files on RAID1, RAID0+1 or RAID1+0. The RAID level of the Symmetrix devices storing the log files of 3 (model, msdb, master) on Windows cluster node **spo-info396** of MSCS **MSCLUSTER05** do not meet this standard. This might lead to performance degradation (see impact).

Since the database log files are I/O intensive (both read and write), database vendors recommend RAID mirroring (for data protection) and striping (for performance). The recommended RAID levels are:

Allocate storage volumes with a proper RAID level that provides high performance and configure the databases to store the log files on these devices.
